3.3 피해물 확인사항

3.4 손해심사 결정 세부내역

3.4.1 세차기 수리비

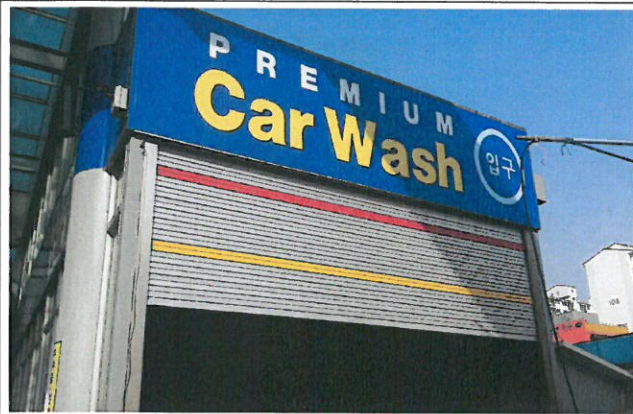
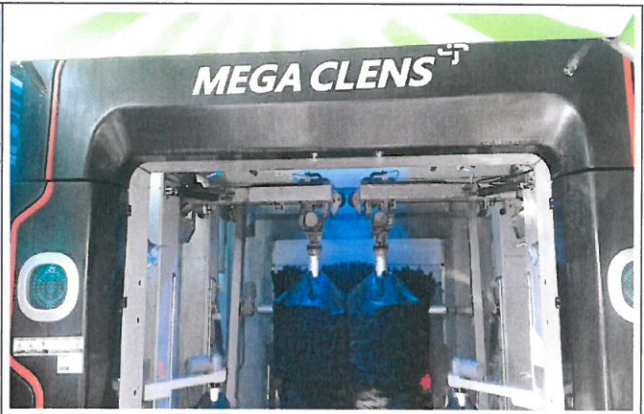
* 한림기계 세차기 확인

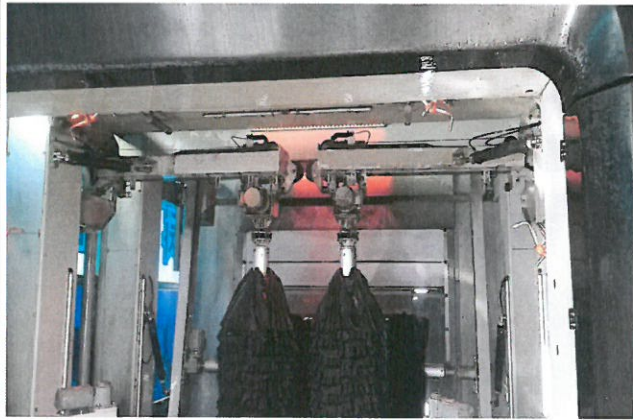
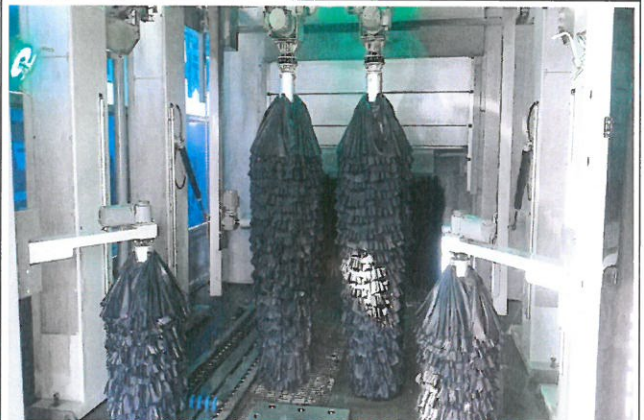
* 사이드 브러쉬 좌, 우 벌어짐 현상

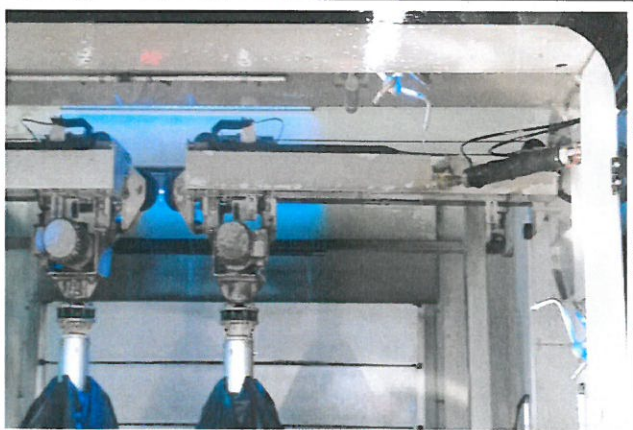
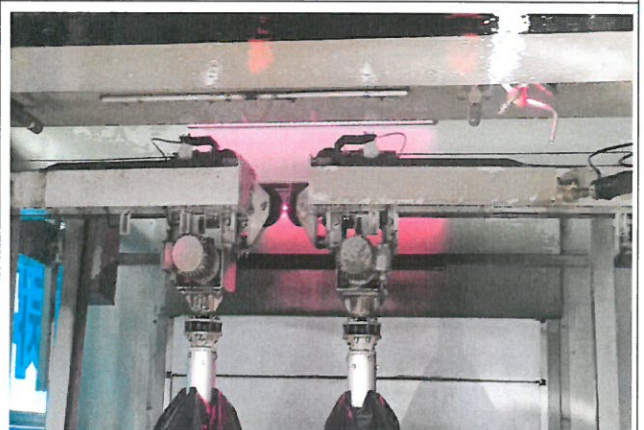
* 브러쉬 유닛 변형 확인
